Glitched on Earth by Humans: A Black-Box Security Evaluation of the SpaceX Starlink User Terminal

Lennert Wouters

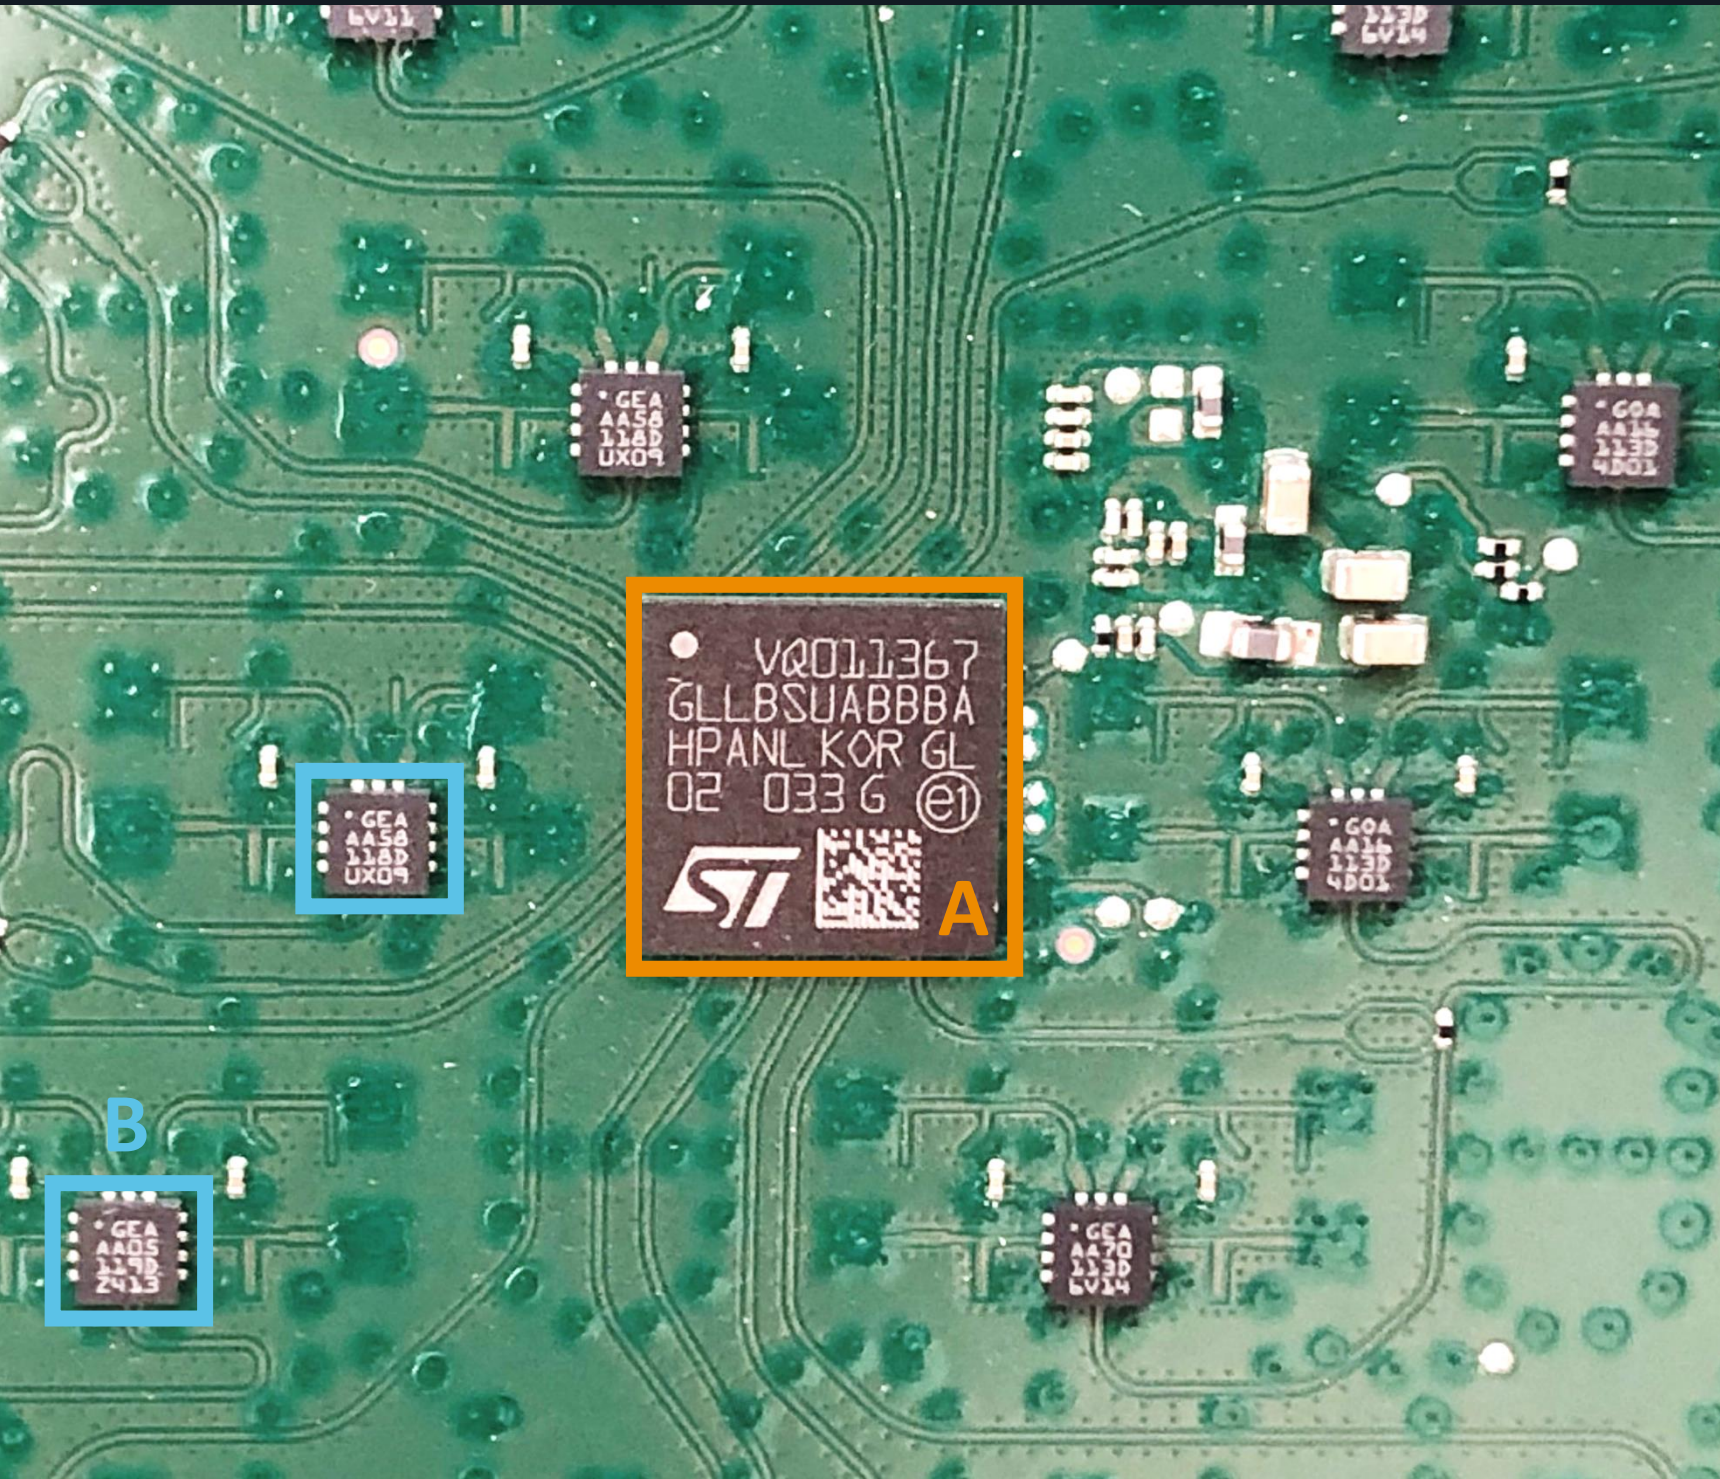
RF Components

- (A) Digital BeamFormer (DBF)
 - STM GLLBSUABBBBA
 - Codename: **SHIRAZ**
- (B) Front-End Module (FEM)
 - Codename: **PULSAR(AD)**
- V2 hardware and up:
 - 1 DBF → 16 FEMs

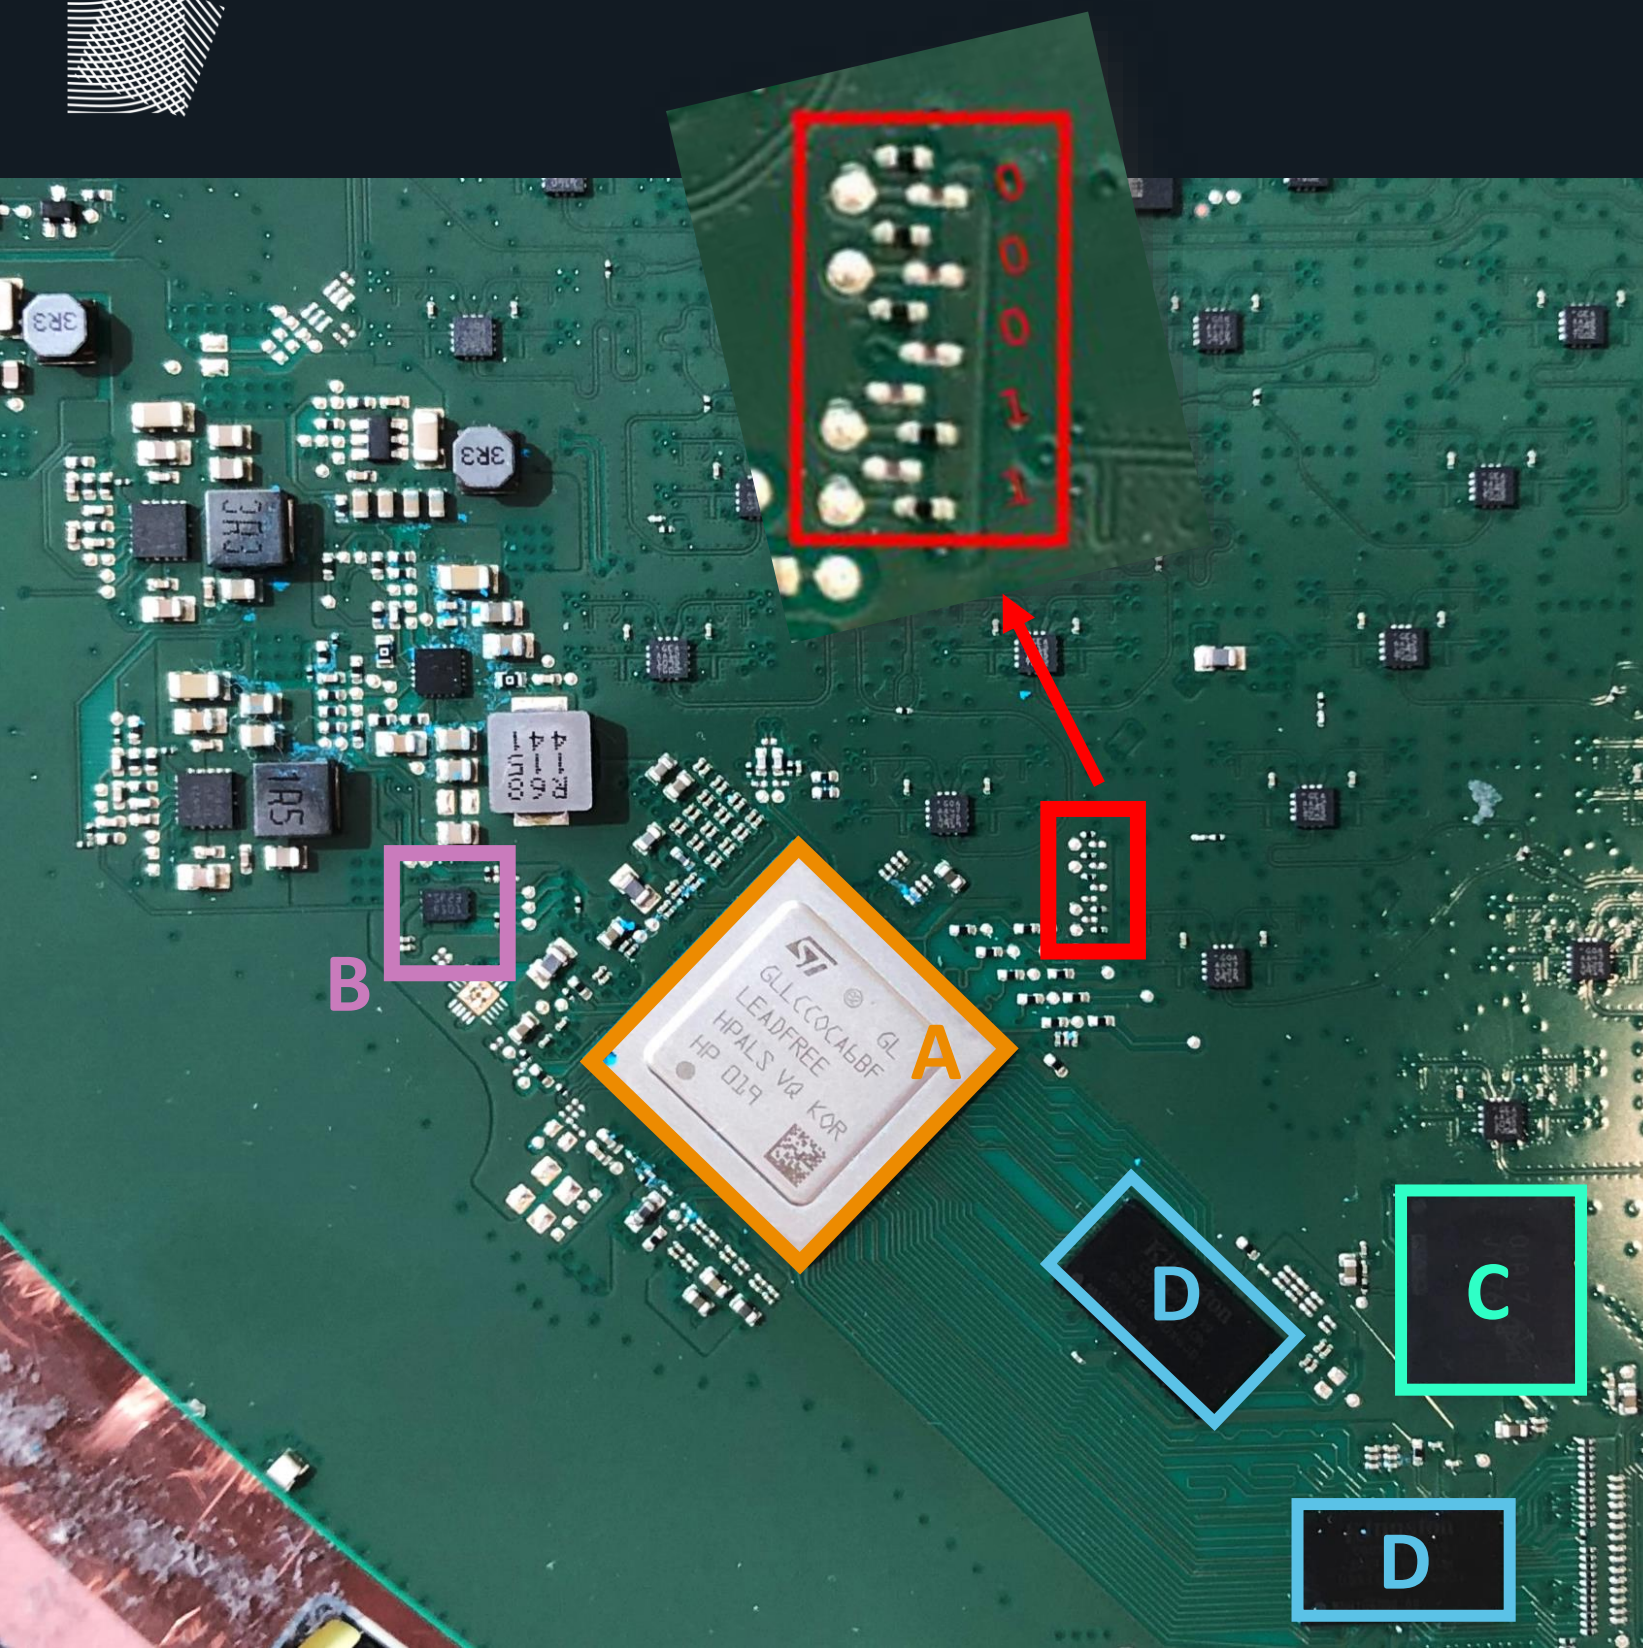
- (A) System-on-Chip
 - Custom quad-core ARM Cortex-A53
 - ST Microelectronics
 - GLLCCOCA6BF (cut 3?)
 - GLLCCODA6BF (cut 4?)
 - Codename: **CATSON**
- (B) Secure Element
 - STM STSAFE-A110
- (C) 4GB eMMC
- (D) 2 x 4Gbit DDR3

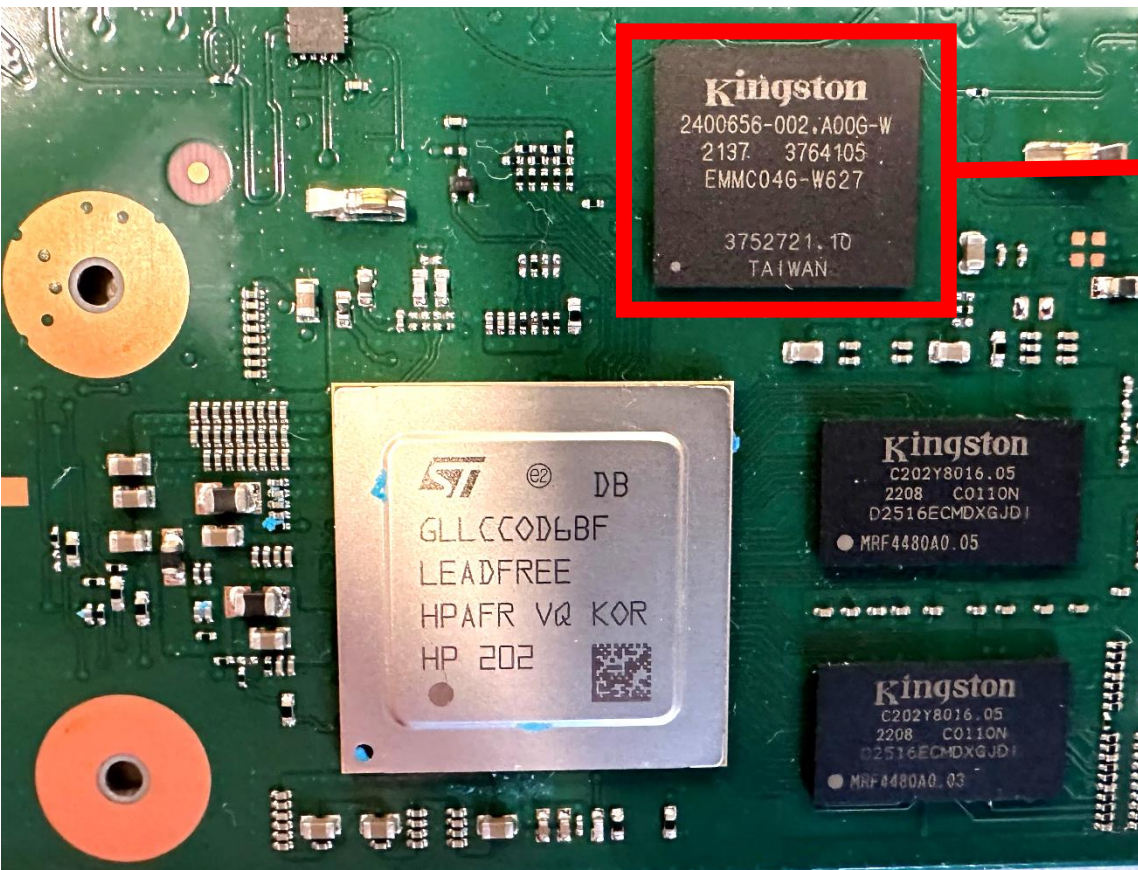
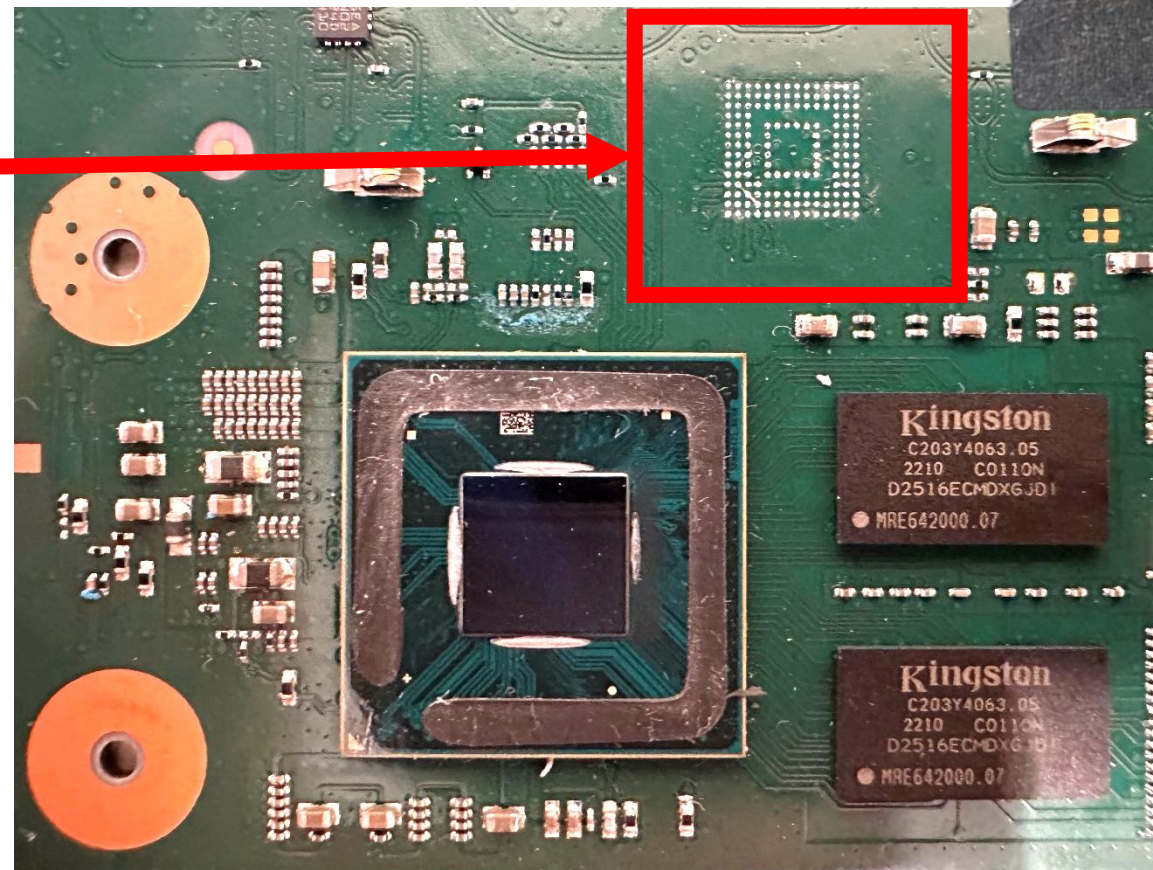
MOORC eMMC socket

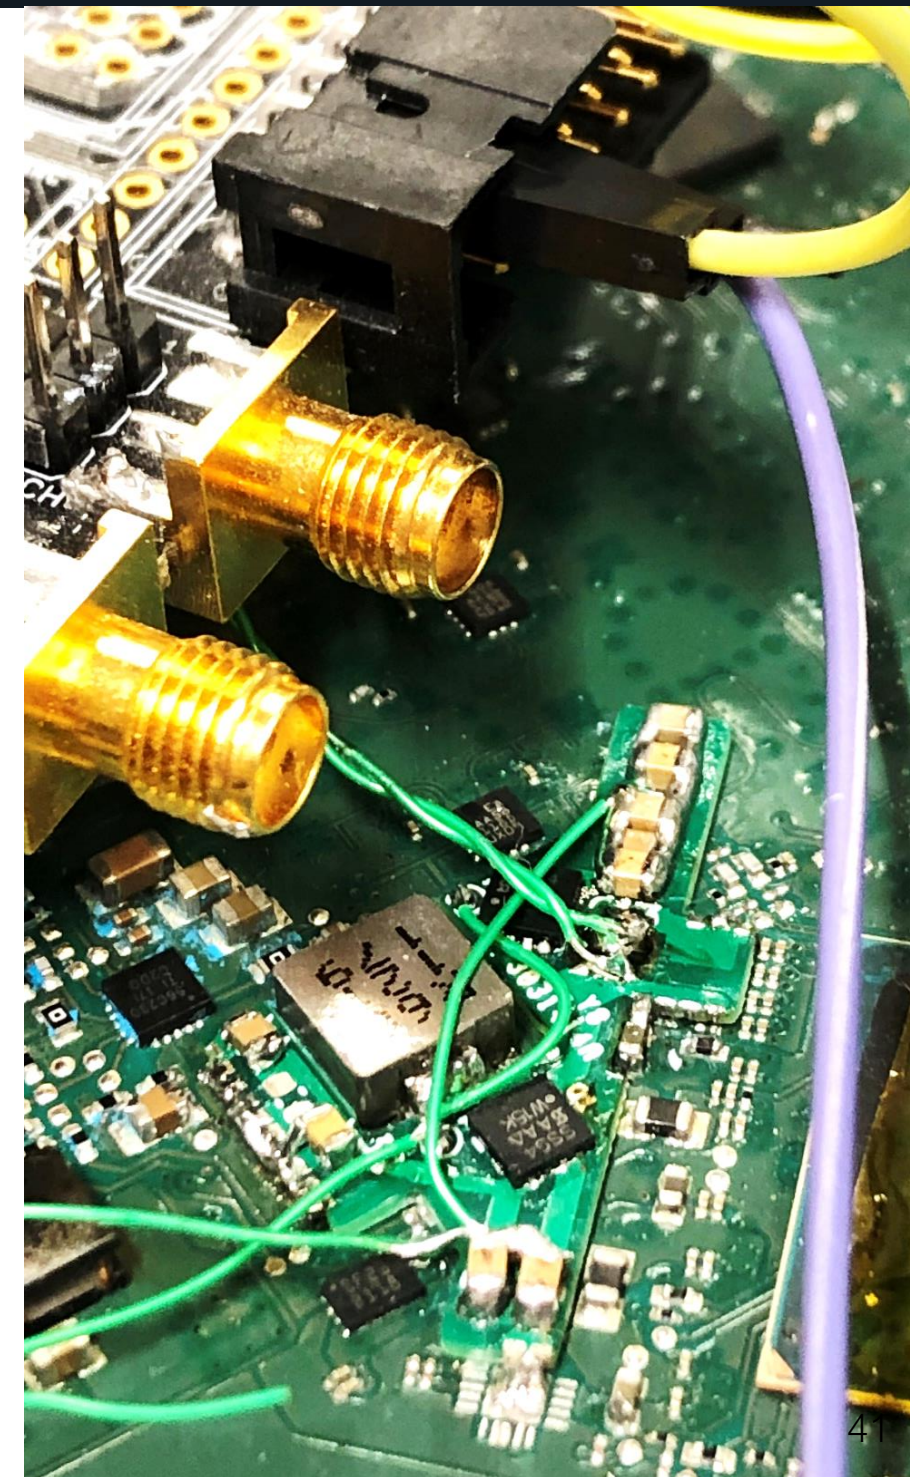
- Decoupling capacitors are needed for later boot stages
- Experimented with:
 - N-channel MOSFETS
 - P-channel MOSFETS
 - High/Low side switching
 - Gate voltage
 - MOSFET drivers
 - Capacitor sizes
 - Timing

Enabling decoupling capacitors

- Bigger is better?!
 - Decoupling capacitor sizes are often determined by their frequency response
 - Larger (47 uF / 100 uF) capacitors seemed to have a more positive influence
 - 100 nF and 1 uF do not appear to be necessary in this design
- (Two) Reverse orientation N-Channel MOSFETs as high-side switches 😬
 - Body diode helps to keep decoupling capacitors partially charged
 - N-channel MOSFETs often have lower $R_{DS(ON)}$
 - 12V MOSFET driver

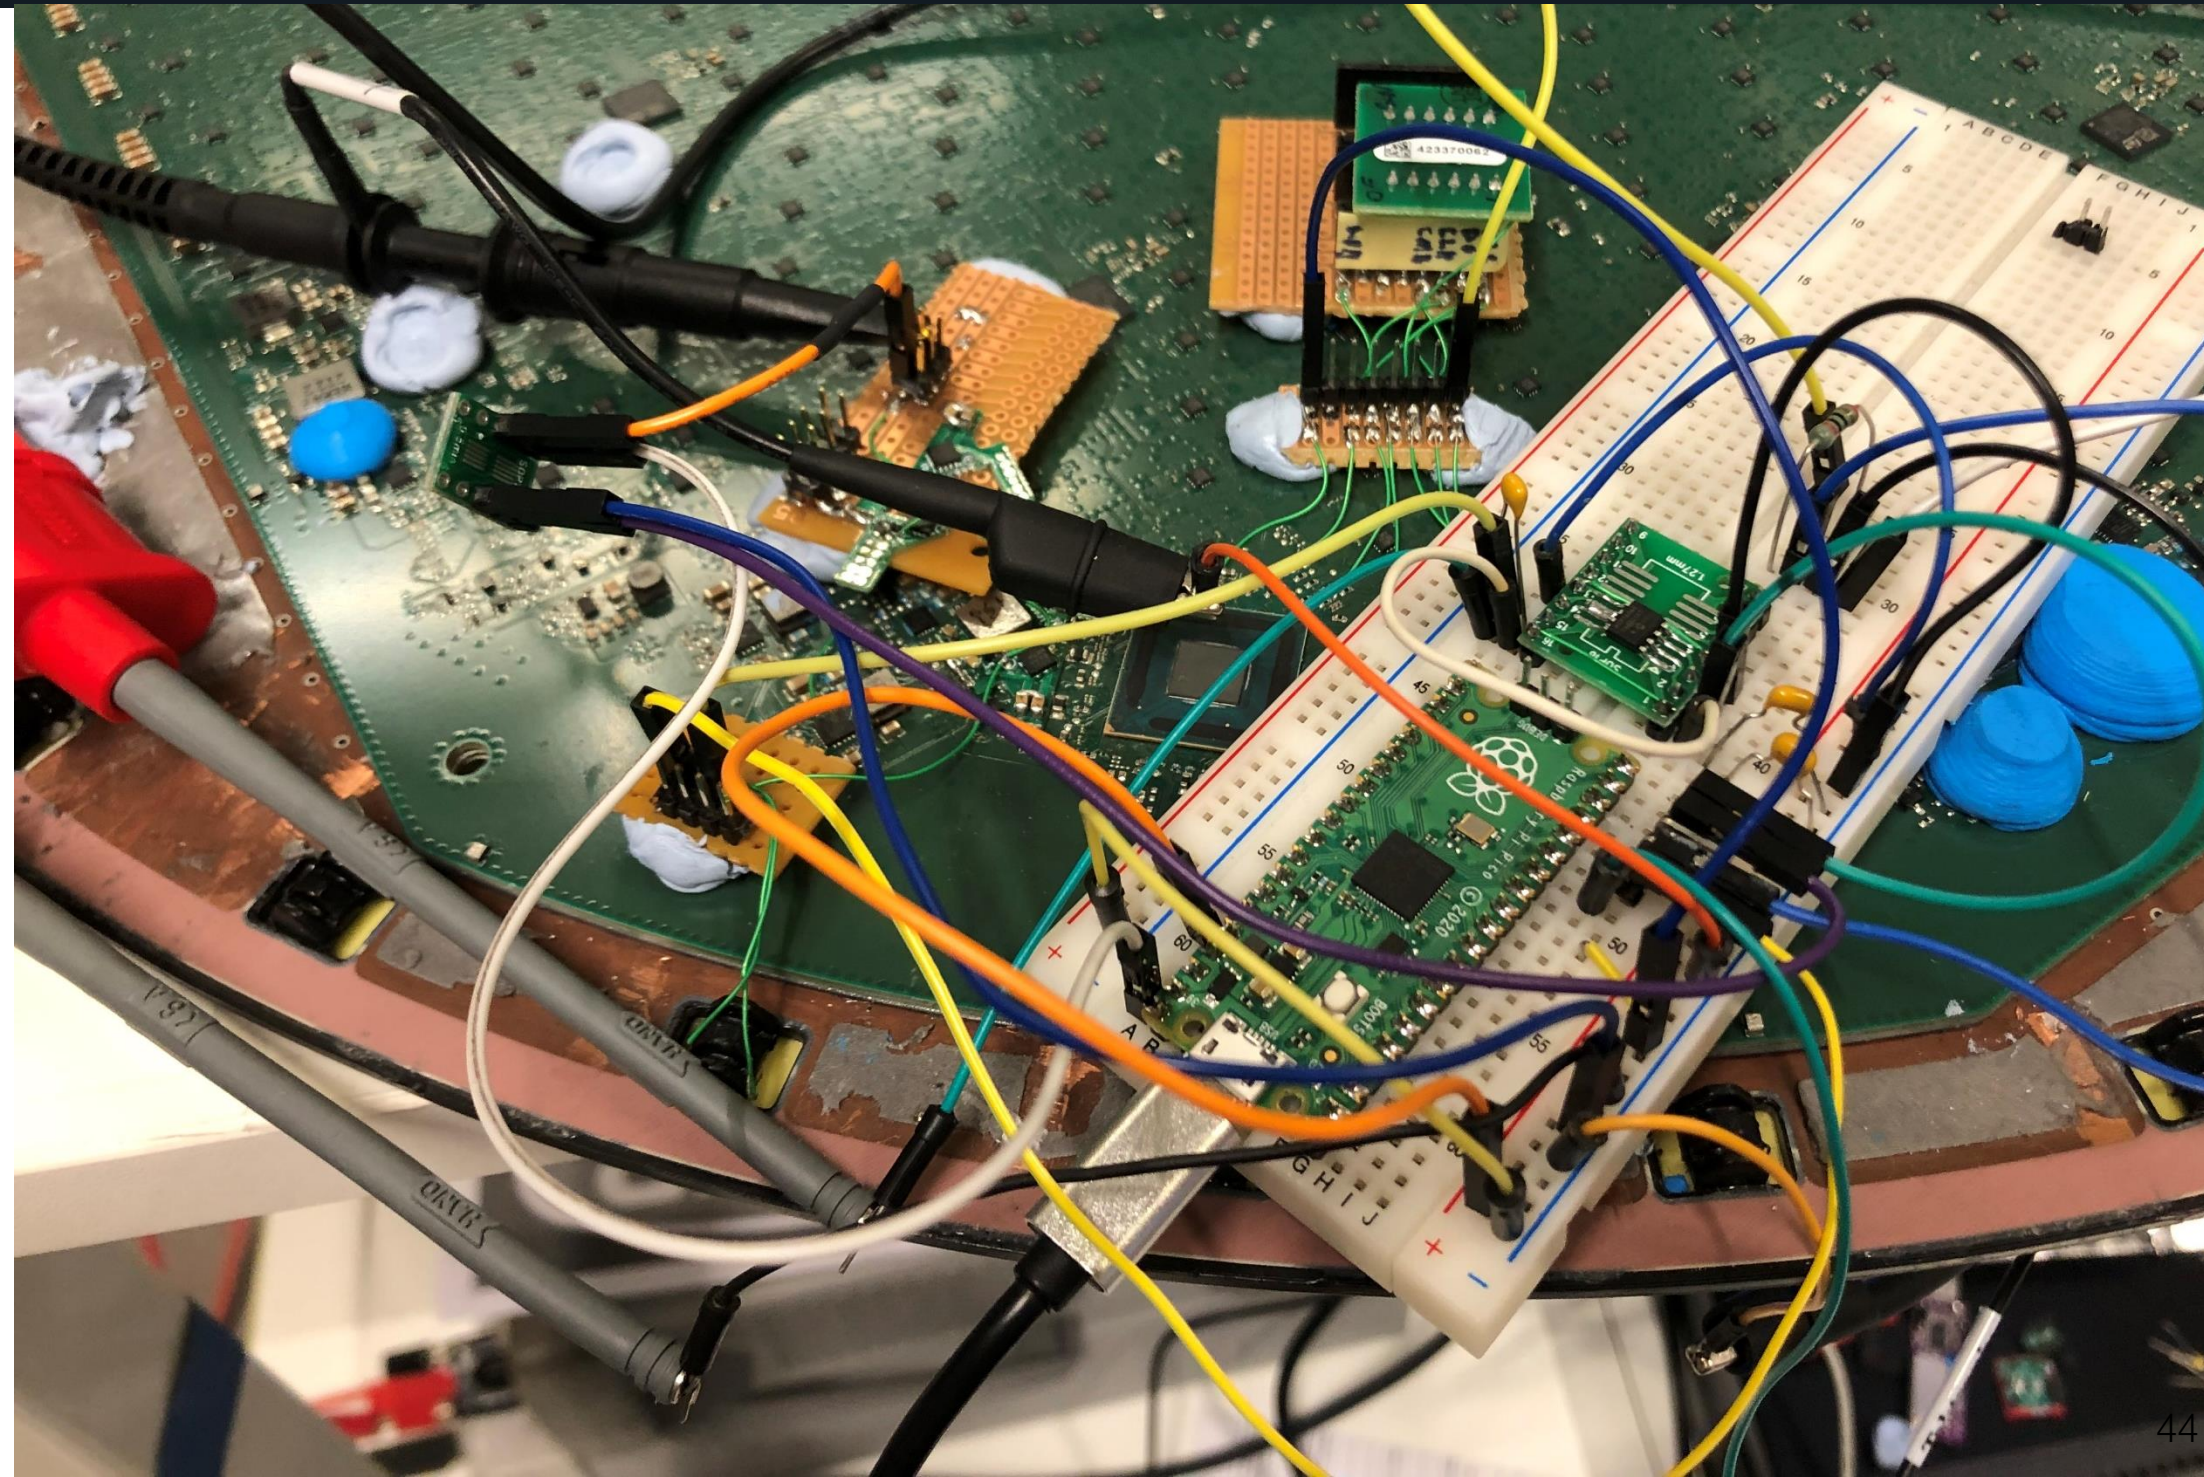
Creating a mobile setup

- Replacing lab equipment with low-cost off-the-shelf components
- RPI Pico replaces oscilloscope and ChipWhisperer
- Works
 - But still messy...
